CONSTRUCTION GENERAL PERMIT SITE INSPECTION REPORT - LEVEL 1 (FOCUSED)

Project Name:	Scott Solar project	Permit Number:	Var10i027
Project Address:	37.53 long 77.94	County/City:	Powhatan
Project Operator:	VA Electric and Power Co	Operator Telephone:	804-380-6362
Project Contact:	Robert Smith Rob.smith@dom.com	Contact Telephone:	404-402-6784
Contact E-Mail:	Scott.lawton@dom.com	Qualified Personnel (QP):	John Healy rld 04703
Inspector:	Matthew Grant	Weather (Wet/Dry/Rain):	Rain
Disturbed Acreage:	155	Inspection Date & Time:	12-12-16 9:30

CONSTRUCTION GENERAL PERMIT SITE INSPECTION PHOTO LOG

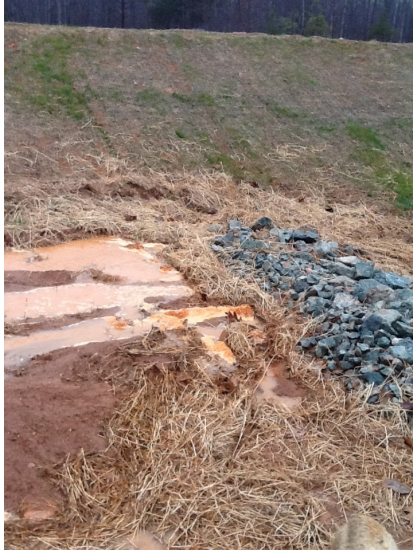
Observation: erosion is occurring on one side of rock check dam

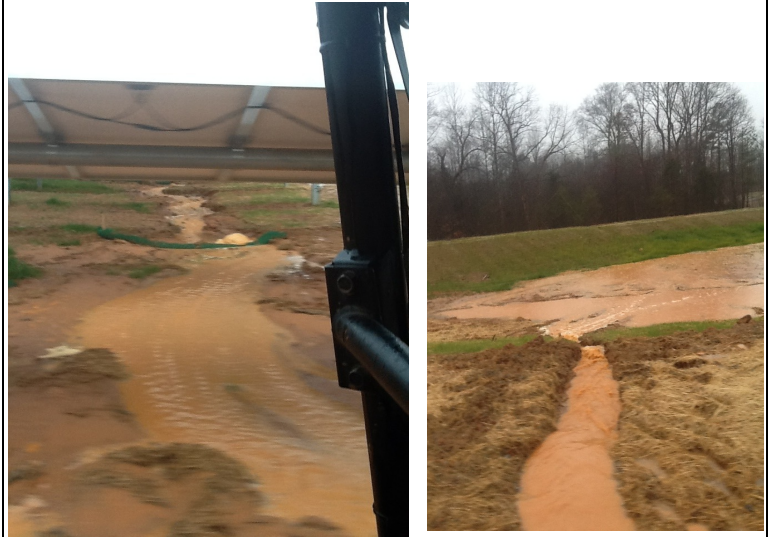
Observation: stormwater on site has channelized and caused erosion

Site inspection was conducted with Rob Smith and John Haley. Continue to stabilize and disperse channelizing flows, update SWPPP accordingly.

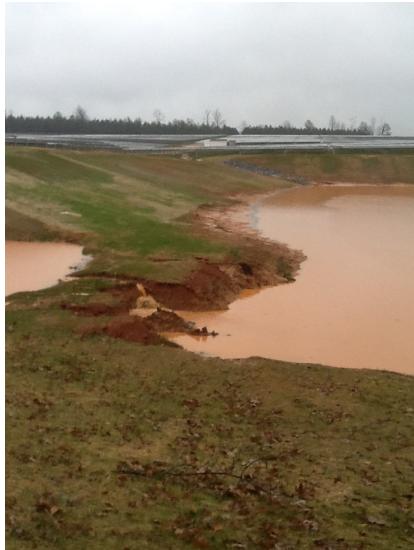
Observation: pond 2 finger forebay of has failed

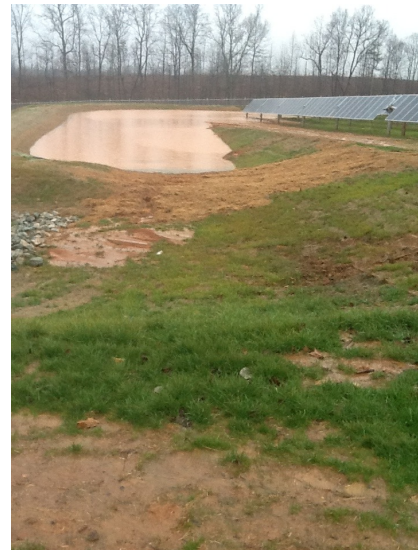
Observation: bio retention embankment is showing signs of erosion
